Monthly Progress Report

Project Name, Location :Ajnara Le-Garden ,Sector-16B, Greater Noida West

Report No : 05

Period : January 2026

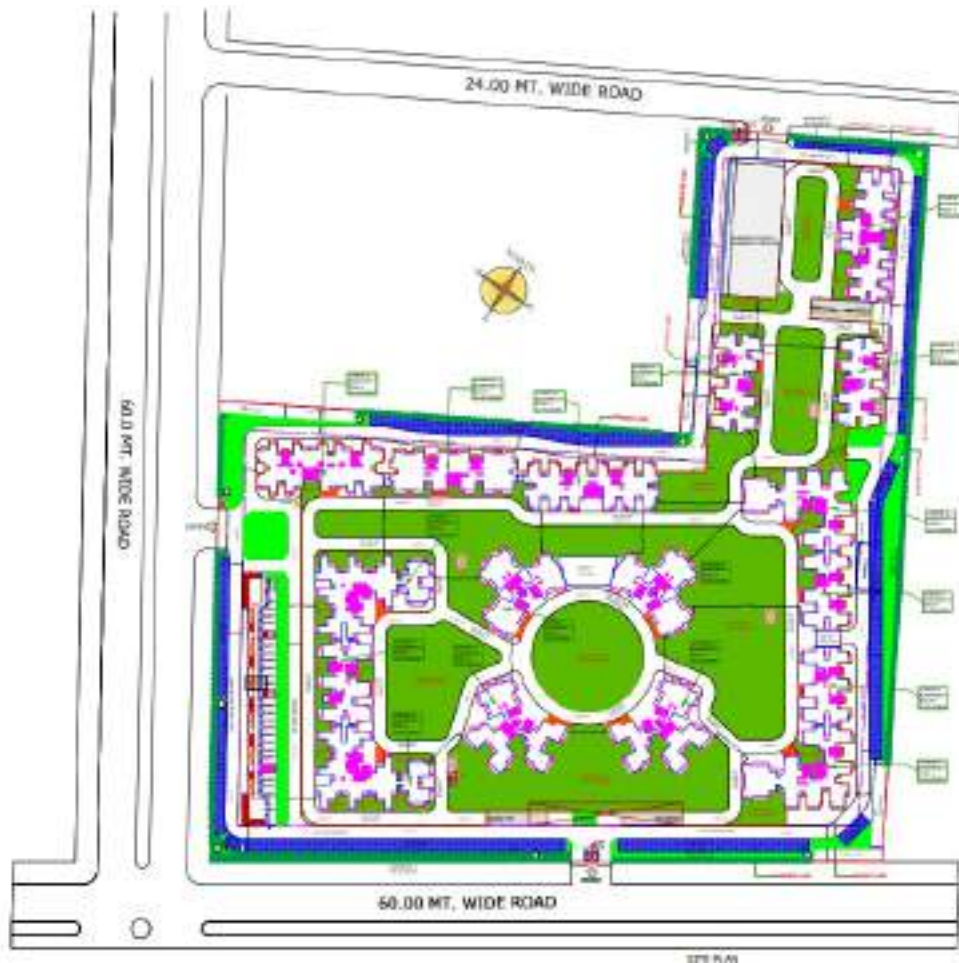
Site Plan as per UP RERA website

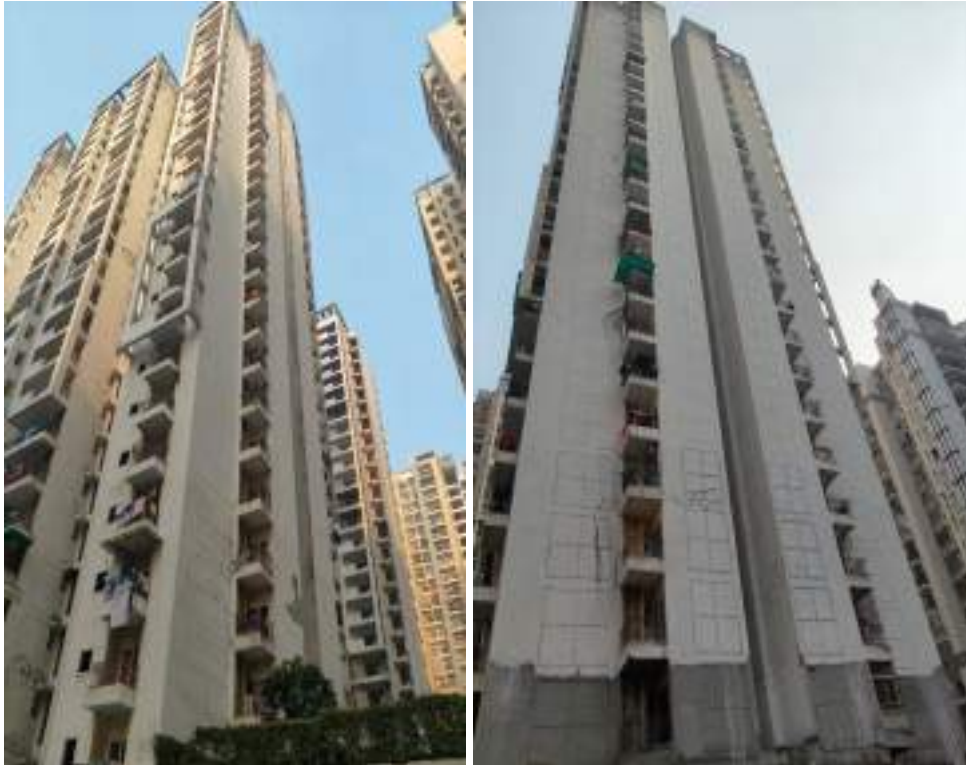
Tower Elevation

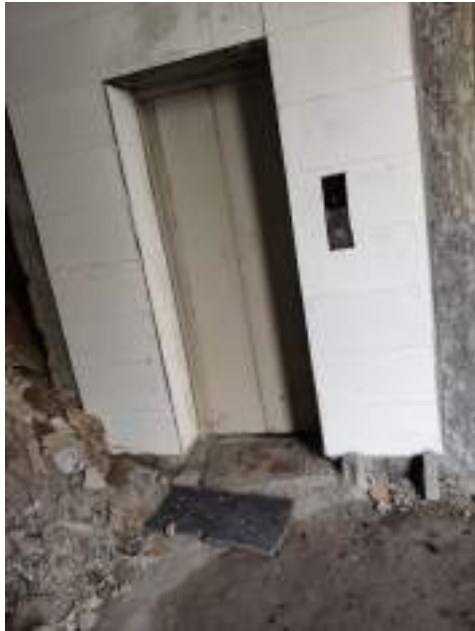
Service Lift

S No.	Activity	Level		
			Status	Remarks
1	Excavation Work	Basement and Non-Tower	Completed	
2	Sub-Structure Work	Basement and Non-Tower	Completed	
3	Structure Work – All Floors	B+P/G+25+ Terrace	Completed	
4	Brick Work	B+P/G+25+ Terrace	Completed	Except 1st Floor
5	Plaster Work (Internal & External)	B+P/G+25+ Terrace	Completed	
6	Electrical Work	B+P/G+25+ Terrace	Pending	
7	Fire Fighting Work	B+P/G+25+ Terrace	WIP	
8	Plumbing Work	B+P/G+25+ Terrace	WIP	Vertical Stack works
9	Sunken Water Proofing	2nd to 19th floor	Completed	Record not maintained
10	Tile work (Room and common area)	2nd to 25th floor	Completed	Except Flat No. 3
11	Tile work (Toilets, Balcony and staircase area)	2nd to 15th floor	Completed	
12	Plaster Repairing work like Toilets and balconies area etc.	2nd to 16th floor	Completed	
13	Putty, Painting (Internal & External)	B+P/G+25+ Terrace	Yet to Start	
14	All Lift work		WIP	Service Lift Installation Completed

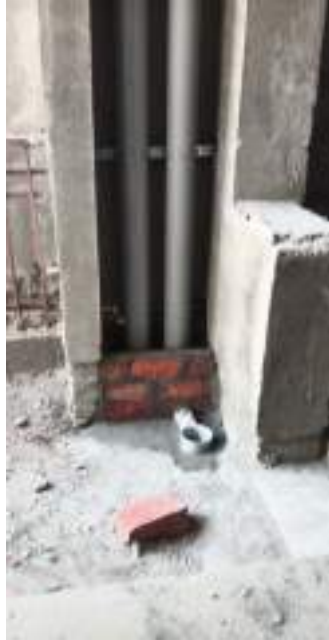
Vertical Stacks-Plumbing Shafts

- Service lift installation completed, testing & commissioning balance
- Plumbing work completed up to 24th floor, only in case of flat no. 3rd completed till 20th floor.
- Internal plaster repairing partially completed at 14th floor.
- Floor tiles fixing at 13th floor flat 3rd (Note- Work in flat no -03 is delayed due to material hoist)
- Podium floor Back filling and dressing work in progress.

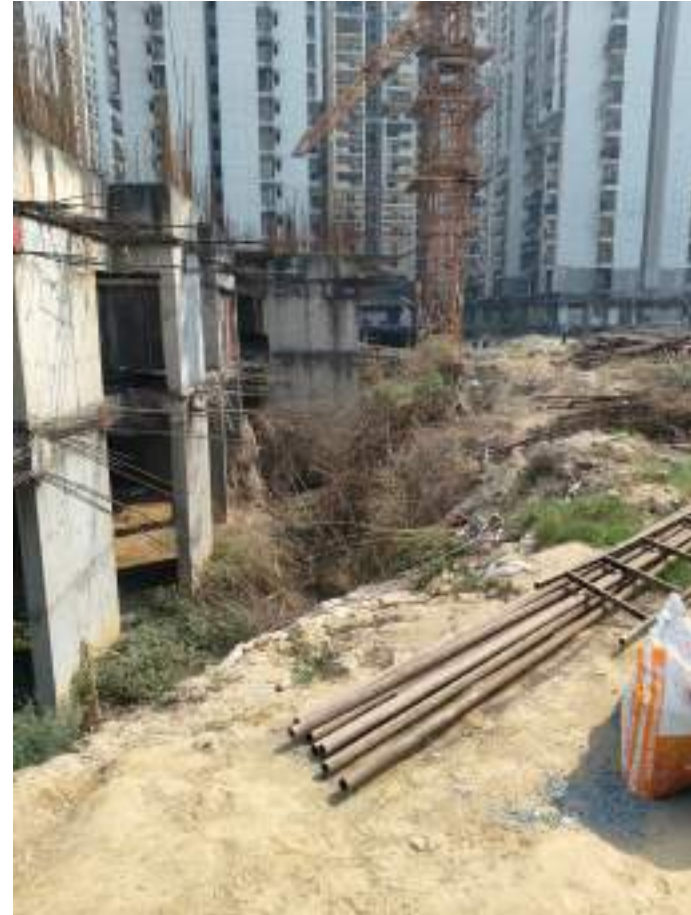
Tower P & Surrounding NTA
