Monthly Progress Report

Ajnara Le-Garden, Location :Ajnara Le-Garden ,Sector-16B, Greater Noida West

Report No : 06

Period : February 2026

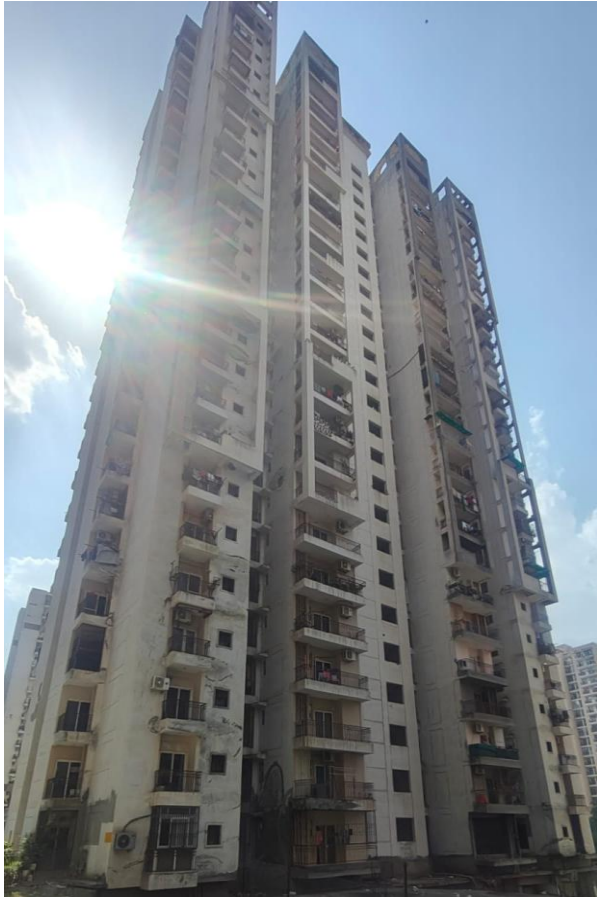
Tower Elevation

Tower-O : Photographs (Tower Area)- No work is done in Feb'26

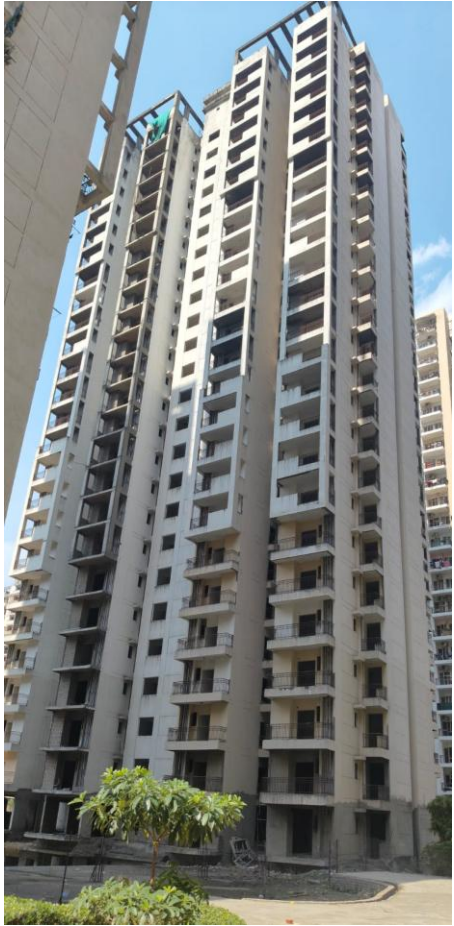
Tower Elevation

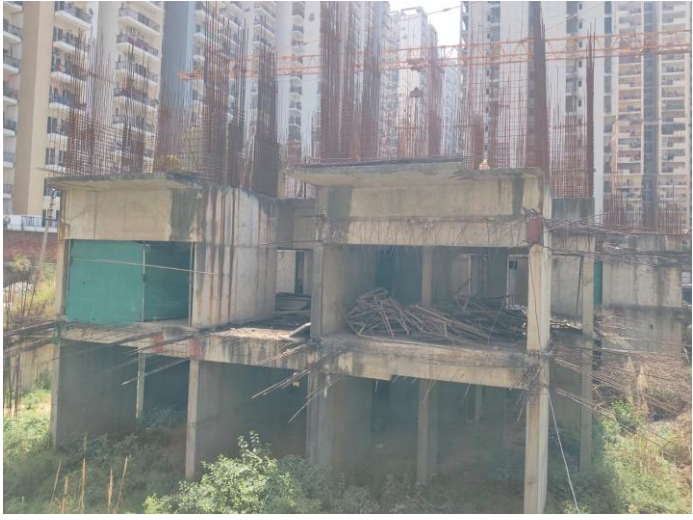
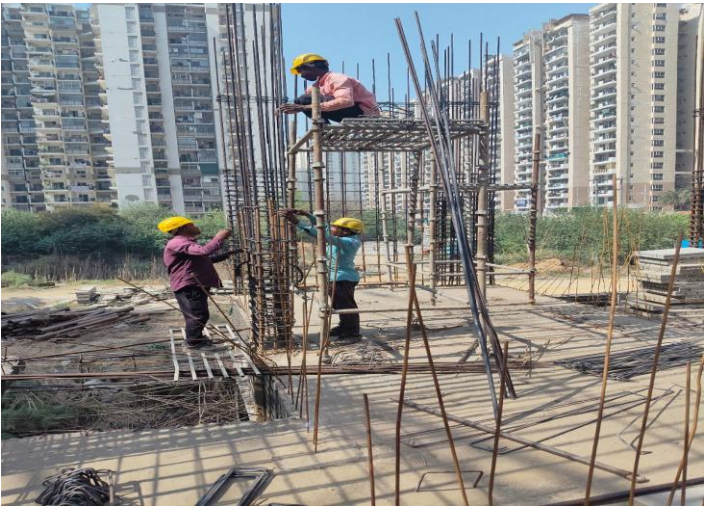
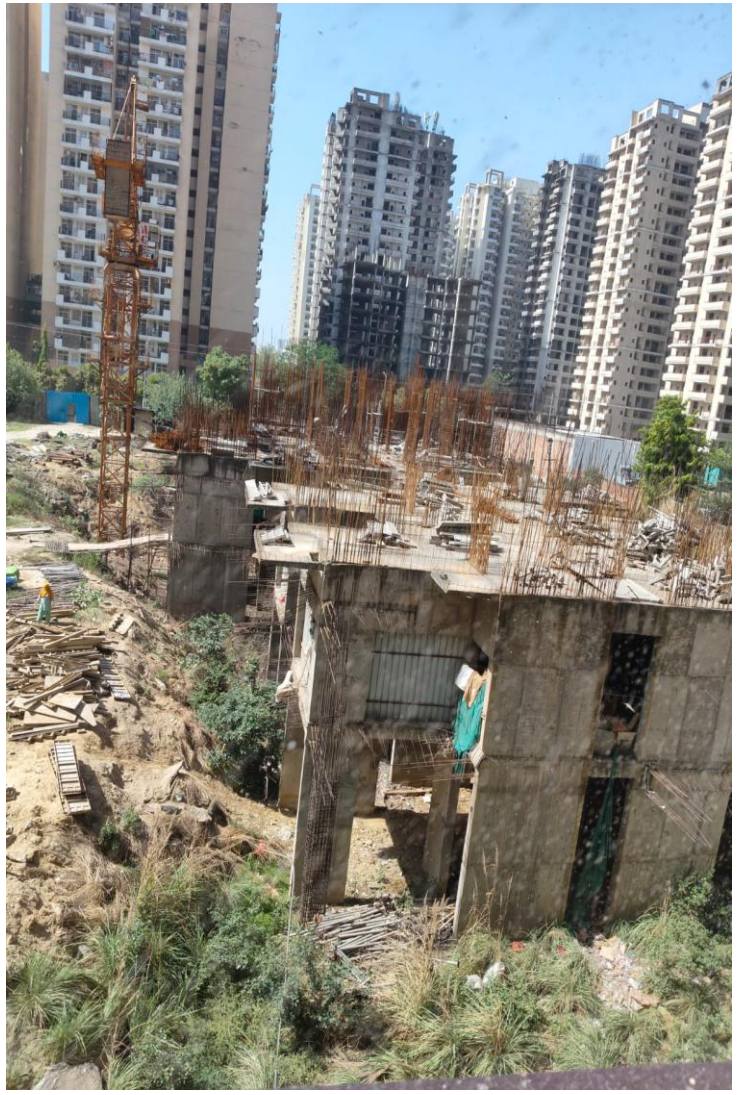
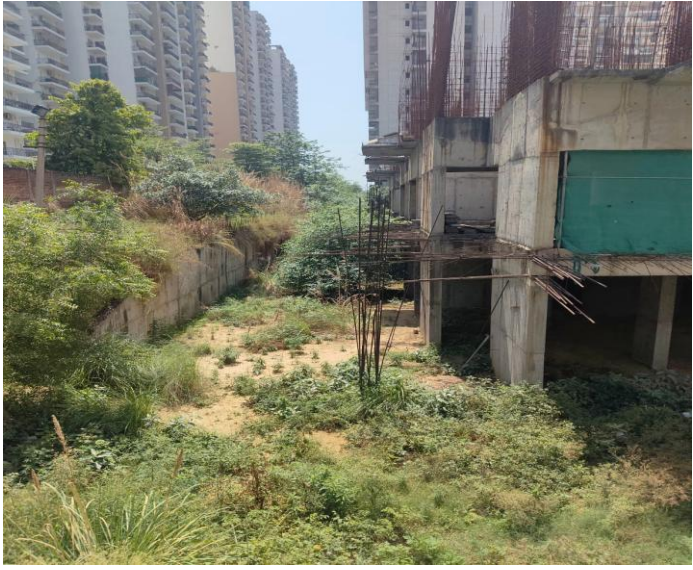
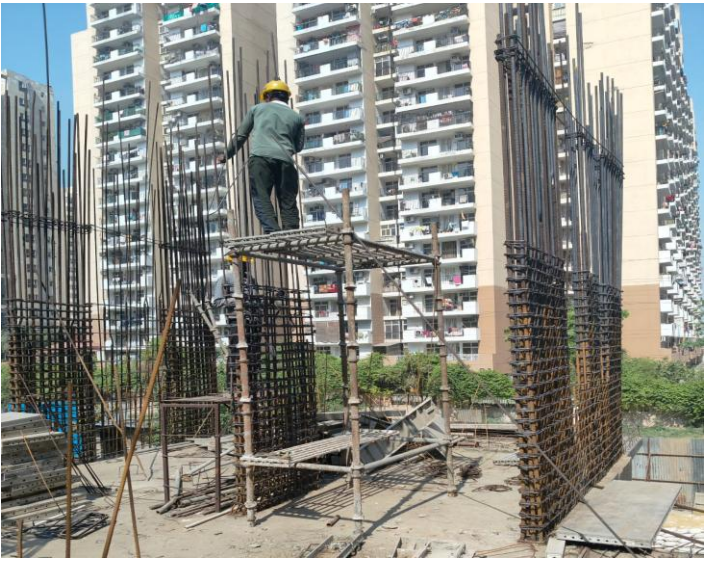
Tower P & Surrounding NTA

Sr. No.	Activity	Level	TQC Onboarding	
			Status	Remarks
1	Excavation Work	Basement and Non-Tower	Completed	
2	Sub-Structure Work	Basement and Non-Tower	Completed	
3	Structure Work – All Floors	B+P/G+20+ Terrace	Structural Work of Basement and Podium/Ground Floor Completed	1 st Floor Column & Steel Binding Work in Progress
4	Brick Work	B+P/G+20+ Terrace	Yet To Start	
5	Plaster Work (Internal & External)	B+P/G+20+ Terrace	Yet To Start	
6	Electrical & Fire Fighting Work	B+P/G+20+ Terrace	Yet To Start	
7	Putti, Painting (Internal & External)	B+P/G+20+ Terrace	Yet To Start	
8	All Lift work & Terrace Work		Yet To Start
